# Taking stock of British Columbia's fish habitat

A report on the Kalum Forest District

By John Werring, M.Sc., R.P. Bio

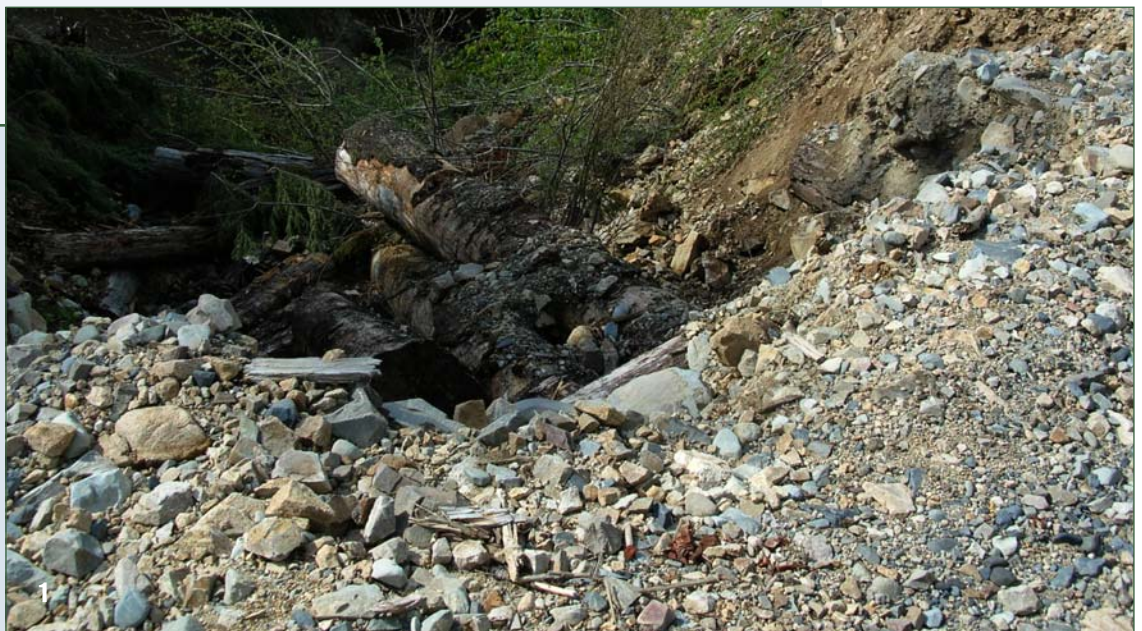
**Kilometre 1** | At spur 300, there was a significant roadside slope failure at a major wooden box culvert. The culvert was in place to direct road ditch flow toward a salmon and coho-bearing tributary of the Big Cedar River. The roads had not been maintained properly and ditchwater was seeping on to the road surface causing extensive erosion and collapse of the culvert.

Most of this debris will eventually end up downstream in fish-bearing reaches of the stream, potentially smothering spawning beds and lowering the water quality for fish.

At spur 300, approximately 80 m<sup>3</sup> of road material and logs from the culvert superstructure had collapsed into the channel below.

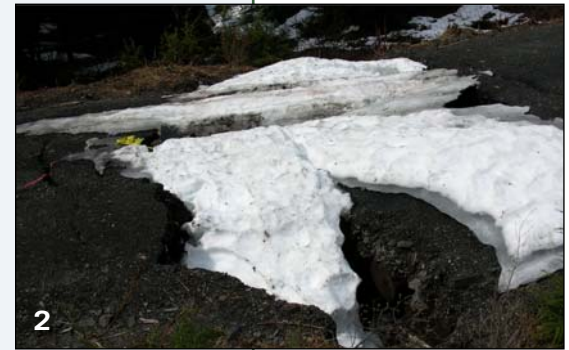
**Kilometre 30** | A three metre wide stream was flowing through a culvert/bridge and under the road. The condition of a culvert/bridge made the road impassable. The road surface over the culvert had been washed away and it formed a large crevice in the road prism. The source of the road surface and culvert failure was uncontrolled ditchwater running down a ditchline for approximately 200 metres.

**At kilometre 30, the remaining surface above the culvert was unstable, deeply undercut and prone to further erosion.**

Only partial repair work has been done. The hole in the road surface was filled in to facilitate passage, but the road bed remains unstable and the drainage issues that caused the problem have not been rectified.

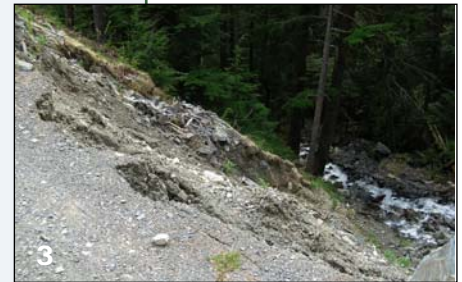
**Kilometre 3.0** | A road failure had deposited approximately 100 cubic metres of silt, sand and rock into a stream that is a direct tributary to Anweiler Creek – an important rearing site to chinook, coho, sockeye and steelhead. The road failure was triggered by large rocks that had fallen from a steep cut slope. A lack of road maintenance had worsened the problem. Failure to properly maintain this road and the fact that the slide had not been fixed or stabilized makes this a potential violation of the *Fisheries Act*.

**Failure to properly maintain this road and the fact that the slide had not been fixed or stabilized makes this a potential violation of the *Fisheries Act*.**

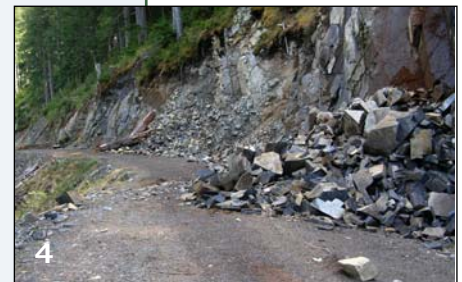
**Kilometre 4.5** | Beyond the bridge crossing at Anweiler Creek, the road surface was littered with debris from road cut slope failures. Virtually every culvert between the bridge crossing at the creek and kilometre 6.0 was plugged with debris. A large section of the side slope of the road had given way and several hundred cubic metres of dirt, rocks, and broken trees were deposited into Anweiler Creek.

**Major cutslope failures and blocked culverts on Anweiler Creek mainline.**

With the exception of clearing some of the debris (rocks, boulders and fallen trees) off the road surface, nothing has been done to fix any of the road related problems at this drainage.

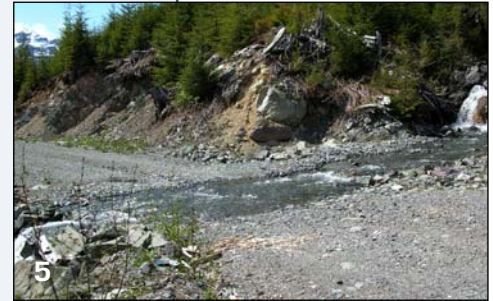
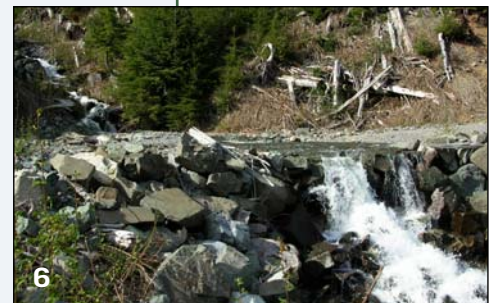
**Kilometre 20** | A blocked culvert was forcing a stream onto the logging route. The stream had eroded the road surface to a depth of approximately 40 centimetres. The erosion channel had been crossed by vehicles on numerous occasions. The road prism was saturated with water. The downside slope of the road was steep enough to suggest an impending road failure. If the road were to give way, nearby fish habitat at Williams Creek (less than 100 metres away) could be smothered by slide debris.

**Kilometre 20.5** | Another plugged culvert had caused white water to spill across the access road. The plugged culverts were only a few kilometres away from an active logging site, but the road had not been fixed. Unstable roadways can eventually lead to erosion with excess sediment ending up in fish streams.

**PHOTOS 5, 6** At kilometre 20 and 20.5, there was stream flowing across the surface of the Williams Creek Forest Service road.

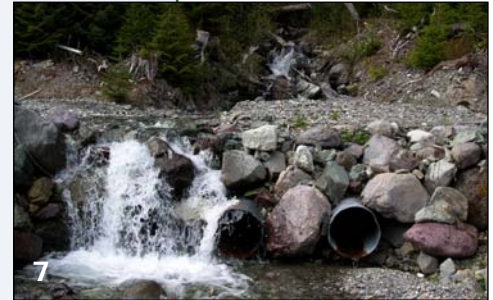
**PHOTO 7** A stream by-passing plugged culverts at the Williams Creek Forest Service road.

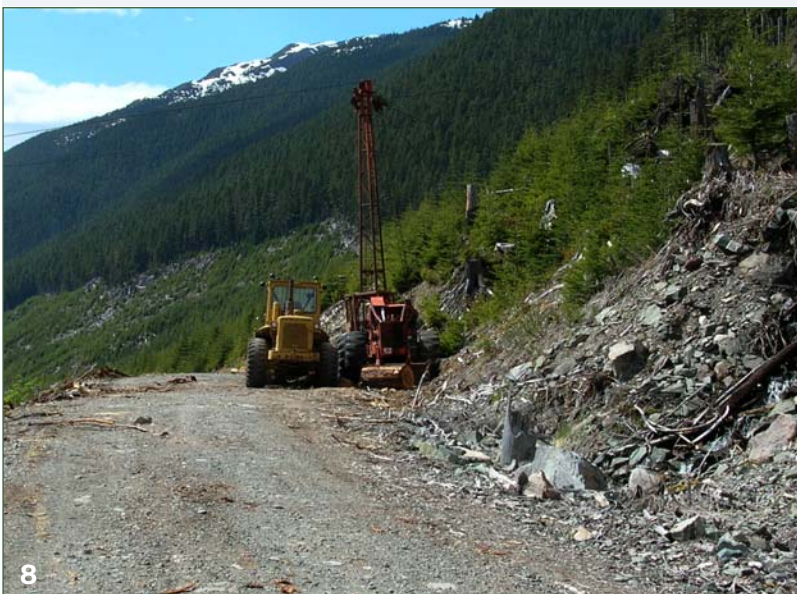
**PHOTO 8** Just beyond the blocked culverts noted above, there was an active logging operation at kilometre 21 on May 12, 2005. Logging trucks would have had to cross streams to access operations.

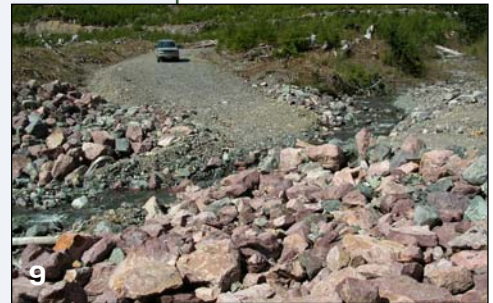
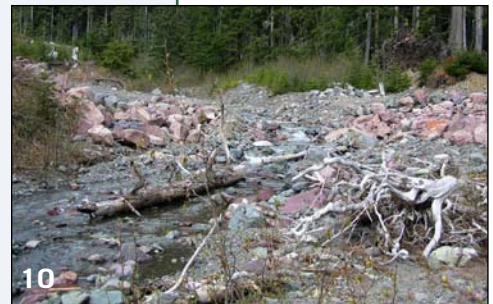
**Kilometre 22** | Within 50 metres of the main Williams Creek forest service road, an intersecting spur road was partially built into a low-gradient tributary. This low gradient stream should have been classified and treated as an S3 fish-bearing waterway (see page 15 for stream classification explanation.) Instead, both sides of the stream had been logged to their banks.

There was no bridge or culvert for fish passage and there were a significant amount of rocks within the stream channel. These rocks were not natural stream sediment. The stones constricted the channel and were smothering what could have been valuable fish habitat. The jagged debris looked as if it had been “blasted” and deliberately placed at the stream, as some pieces had wires and caps attached, while others had gouged holes.

**PHOTOS 9, 10**  
Evidence of road building debris was left in a potential fish-bearing tributary to Williams Creek.

As of September 7, nothing had been done to address these issues.

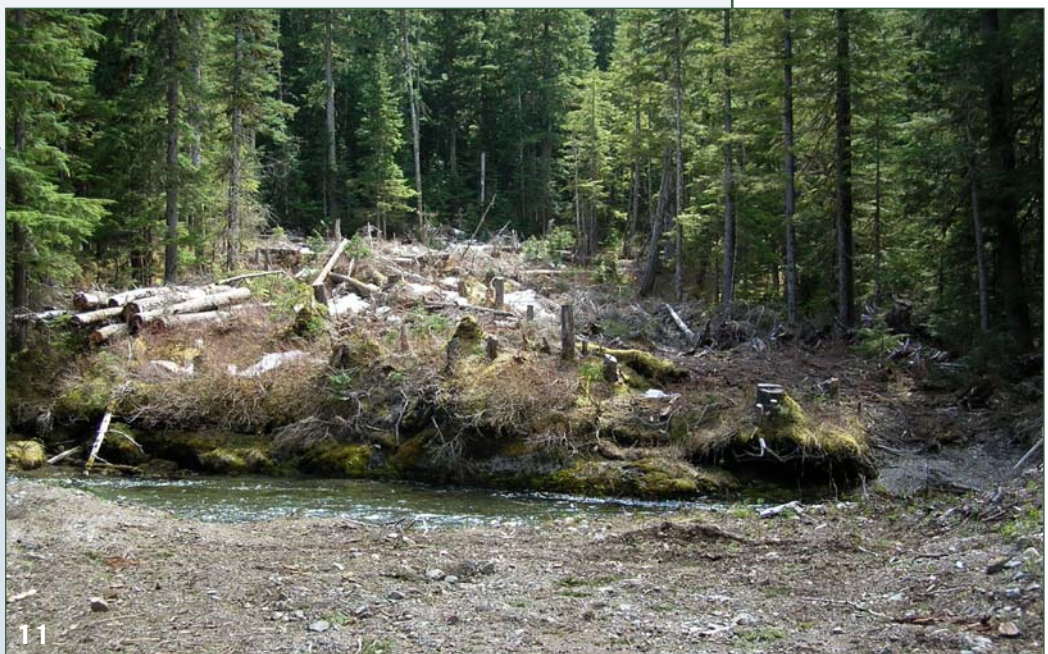
Part of the forest on the far side of Williams Creek had been logged and there appeared to be a skidder trail next to the far side of the bank. Evidently, vehicles had crossed the creek by driving right through the stream.

**PHOTO 11** A logging site on the far side of Williams Creek.

The absence of a properly constructed crossing meant that vehicle traffic and log hauling would have occurred by traversing the Creek (a known fish-bearing stream).
