INVESTIGATION BY THE DAVID SUZUKI FOUNDATION INTO ISSUES OF POTENTIAL ENVIRONMENTAL CONCERN RELATED TO OIL AND GAS DEVELOPMENT IN THE MONTNEY SHALE PLAY IN NORTHEASTERN BRITISH COLUMBIA, AUGUST 14 - 28, 2015

Prepared by John Werring
Senior science and policy advisor, David Suzuki Foundation
November 25, 2015

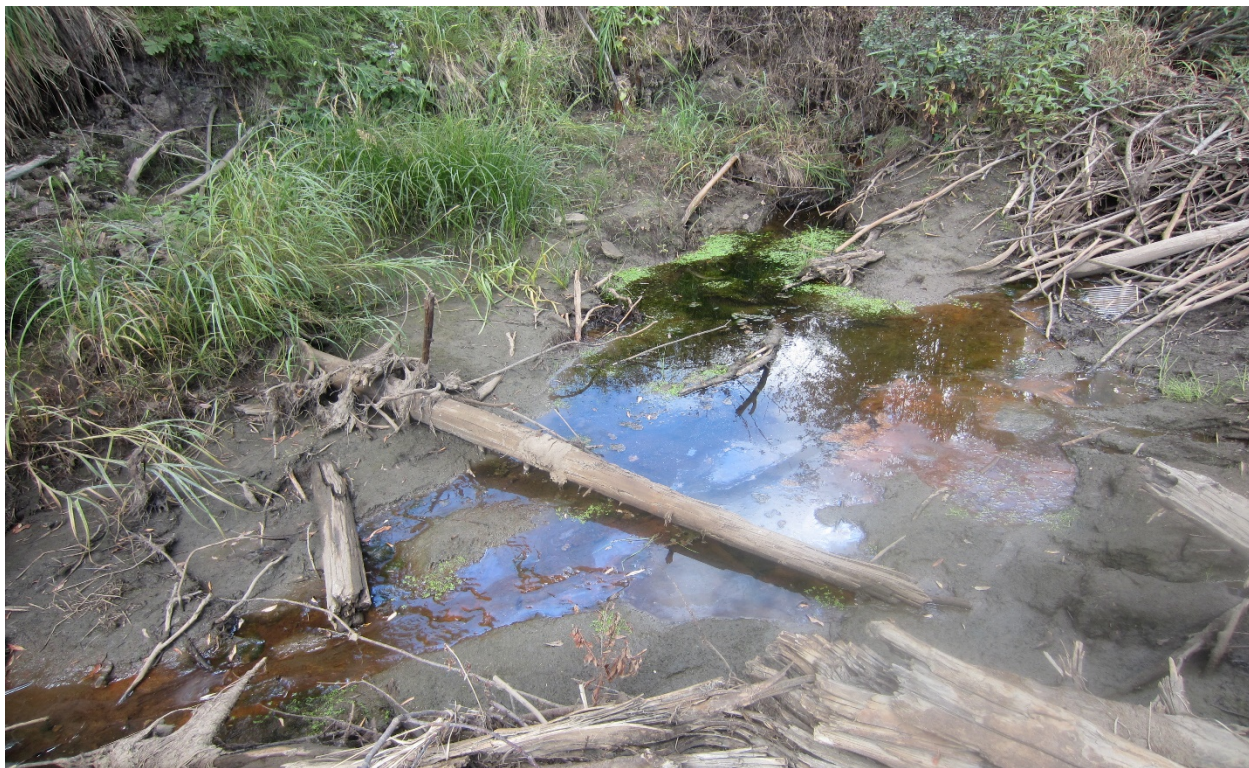
Photo 1. Hydrocarbon sheen in creek water at the bridge crossing on Alexander Creek; August 15, 2015.

We revisited the site where we had documented hydrocarbons leaking into Alexander Creek on August 15, 2015, and observed what we again believed to be hydrocarbons leaking into the creek at the same location and, from our observations, in the same amounts or in even greater quantities. The presence of these hydrocarbons was documented in photographs (see photos 1-4). As in our previous site investigation, we also poked and prodded the surface sheen with a stick to see if it would break up, but it did not. There was some separation of the sheen upon prodding but it rapidly coalesced. This was an indication that the sheen was likely related to ongoing hydrocarbon contamination. We also could smell the distinct odour of hydrocarbons while manipulating the water's surface and on the stick used to prod the sheen.

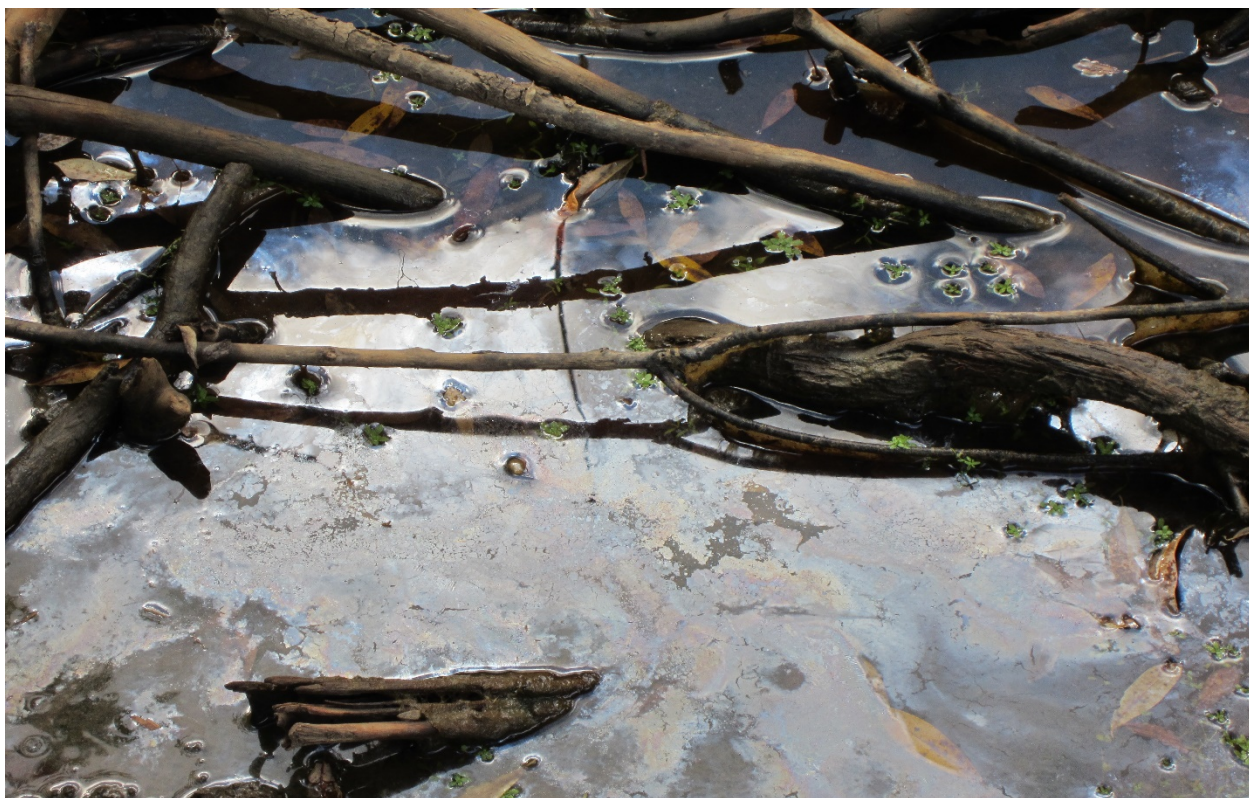
Photo 2. Hydrocarbon sheen on the surface of Alexander Creek; August 15, 2015

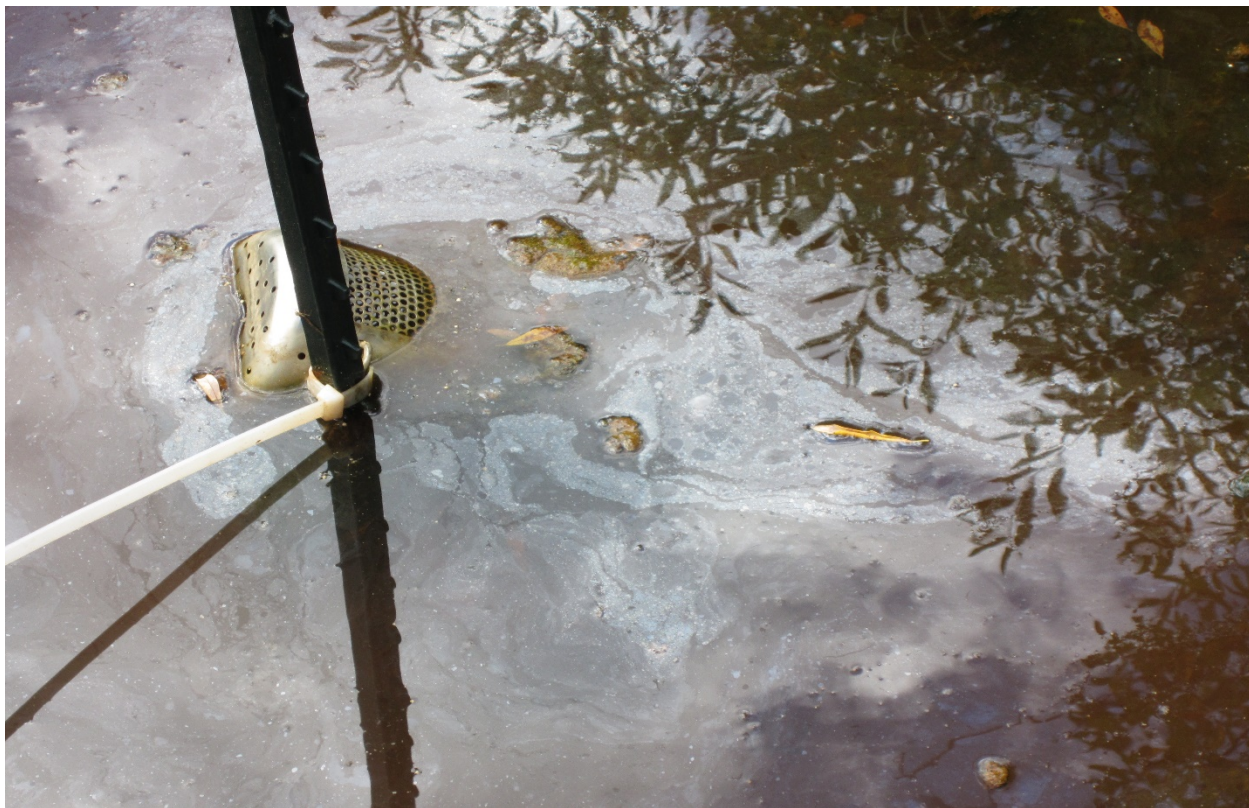
Photo 3. More hydrocarbon sheen at Alexander Creek bridge site; August 15, 2015

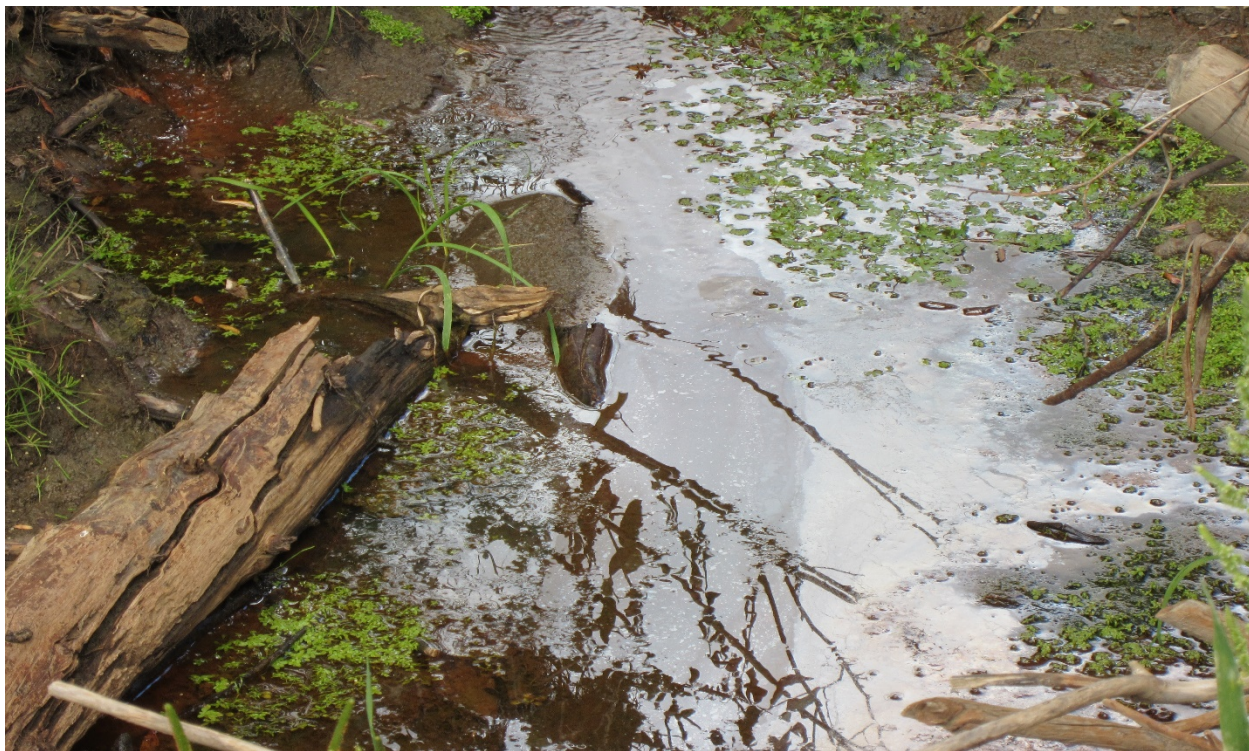
Photo 4. Surface of Alexander Creek at bridge; August 15, 2015

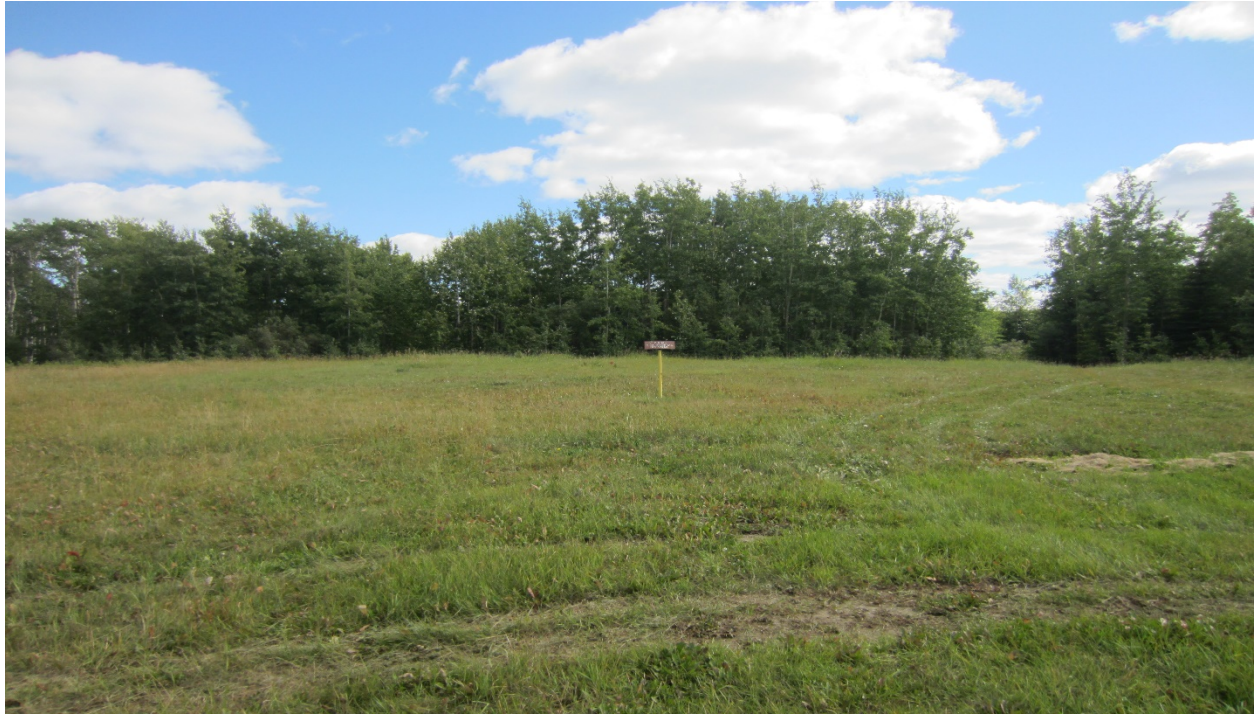
Photo 5. One of only two fully abandoned and restored sites observed in the northeastern B.C. oil patch. This is well site 09-36-085-22 w6 in the Lower Cache area. According to B.C. O&GC data It was completed in 1977 and declared abandoned in 2002.

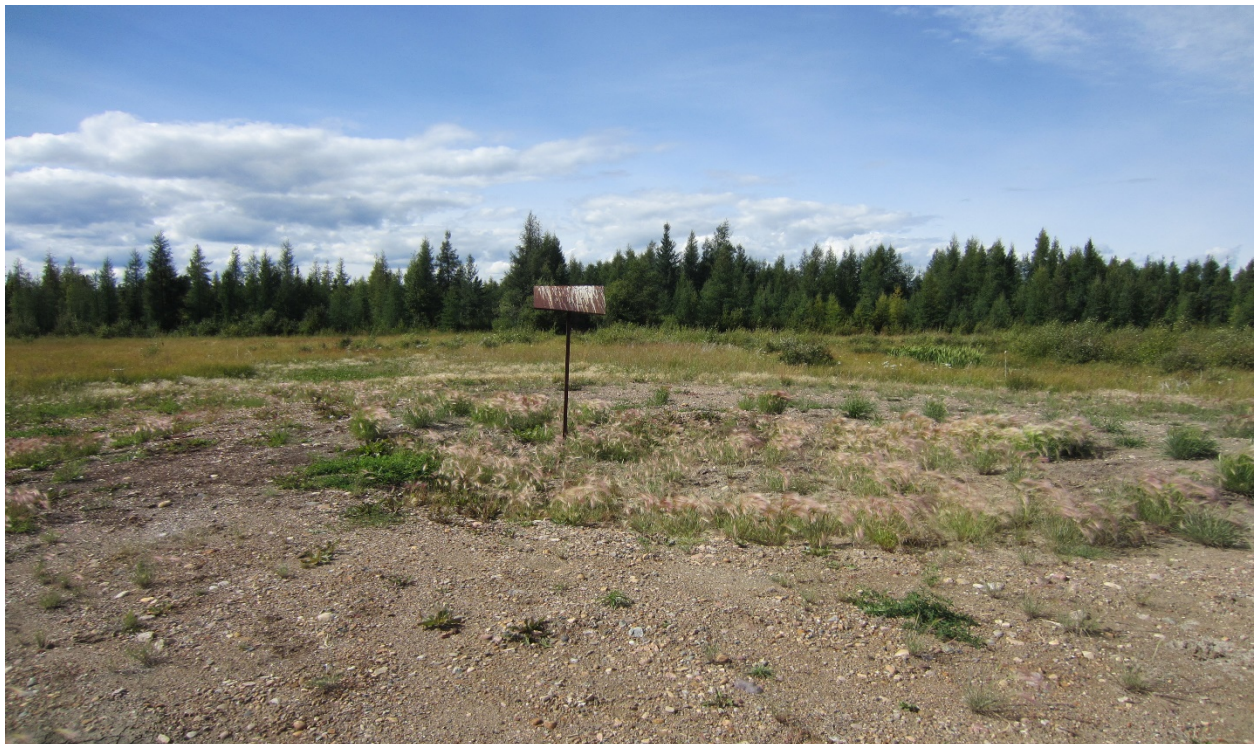
Photo 6. Abandoned well site in the Peejay region. This is well site b-42-H/94-A-15. It was completed in 1968 and declared abandoned in 2006.

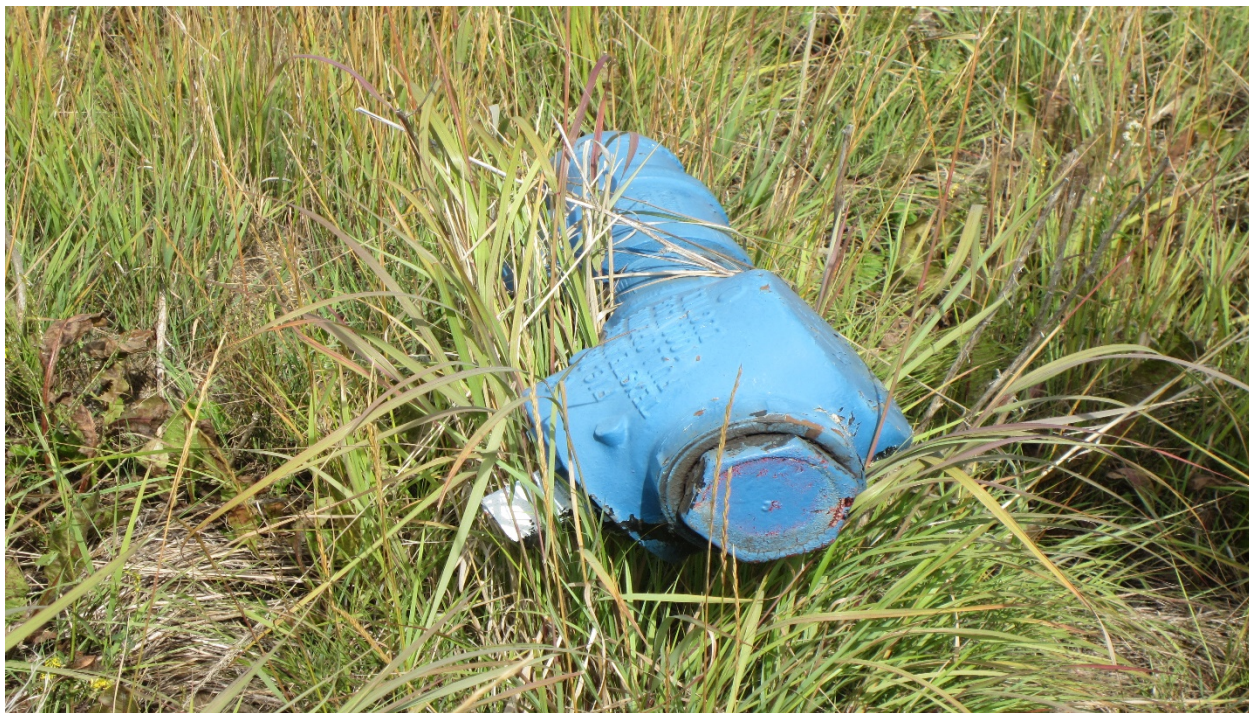
Every one of the other sites, including **all** of the suspended sites, still had surface infrastructure left in place, ranging from remnants of the wellhead (Peejay d-54-H/94-A-15; See Photo 7) to closed and locked-down but complete gas plants and compressor stations (facility site number 15-1-86-22 w6m - Lower Cache; see photo 8). On many of the sites, the soil was still compacted and very little to no vegetation regrowth was observed. All had buildings, pump jacks or above-ground pipeline connections still in place (see photos 9 through 12).

Photo 7. Abandoned well site in the Peejay area (Peejay d-54-H/94-A-15) showing above-surface piping remaining in place.

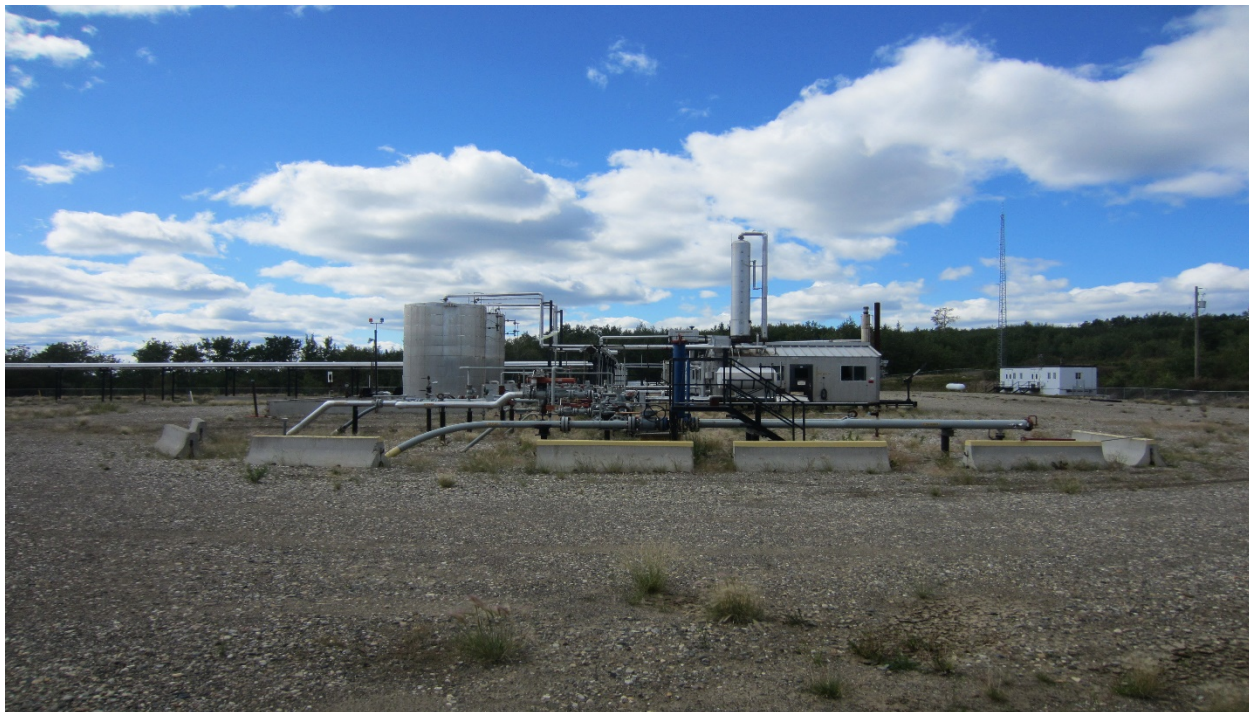
Photo 8. A complete, abandoned gas plant in the Lower Cache area (facility site number 15-1-86-22 w6m). This site was declared abandoned in 2012.

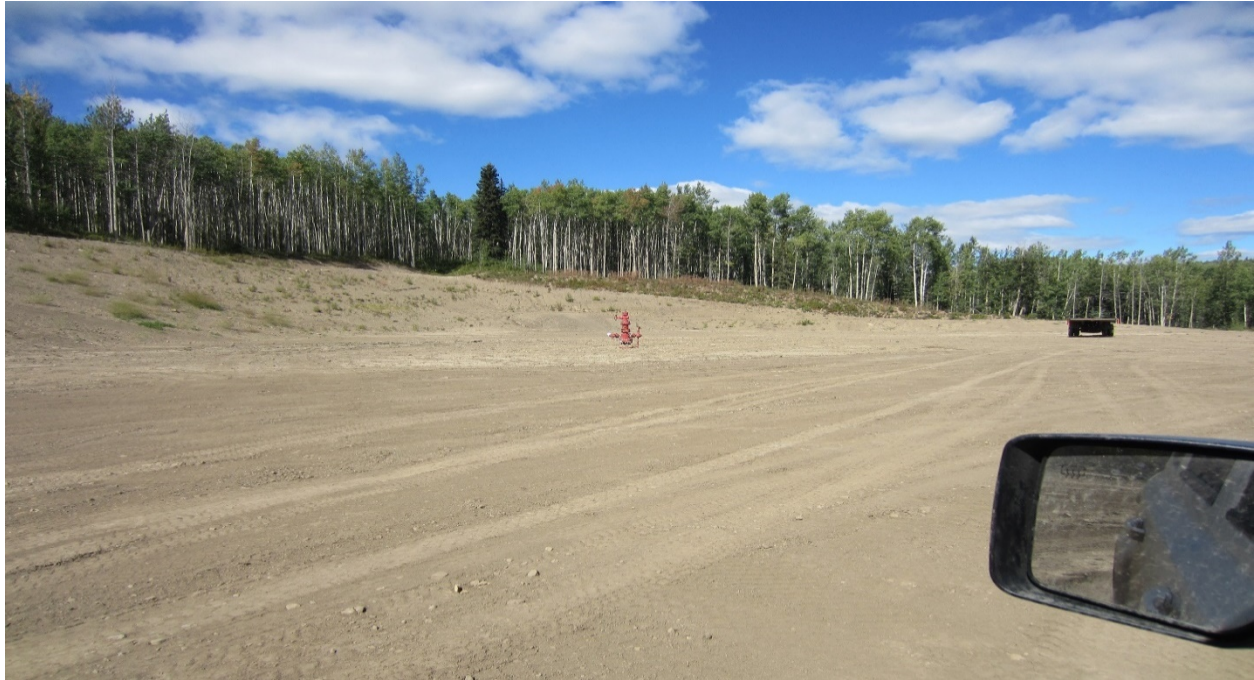
Photo 9. This is well site A13-05-086-21 w6m located in the Lower Cache area approximately 70 km NW of Fort St. John. It could not be determined if this site was abandoned or suspended.

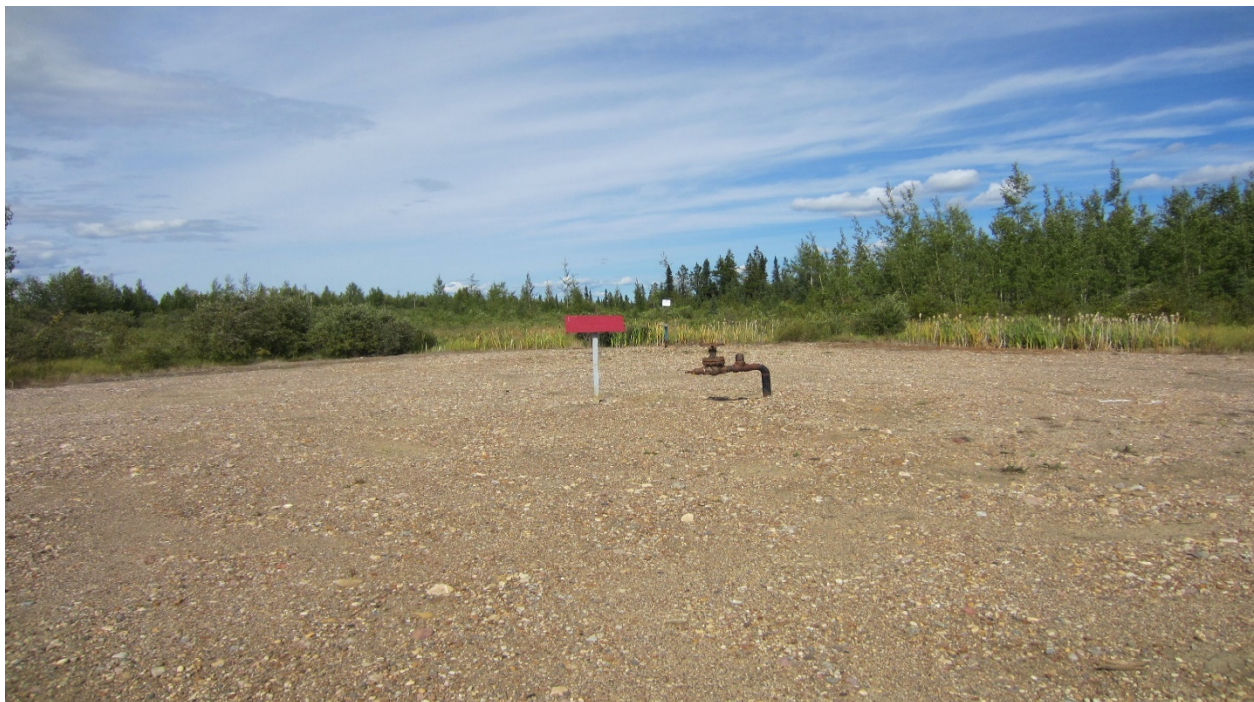
Photo 10. This is well site d-39-E/94-A-16 in the Peejay region. It was completed in 1993 and declared abandoned in 2010. There is still infrastructure on-site (surface pipes) and the site has not been replanted.

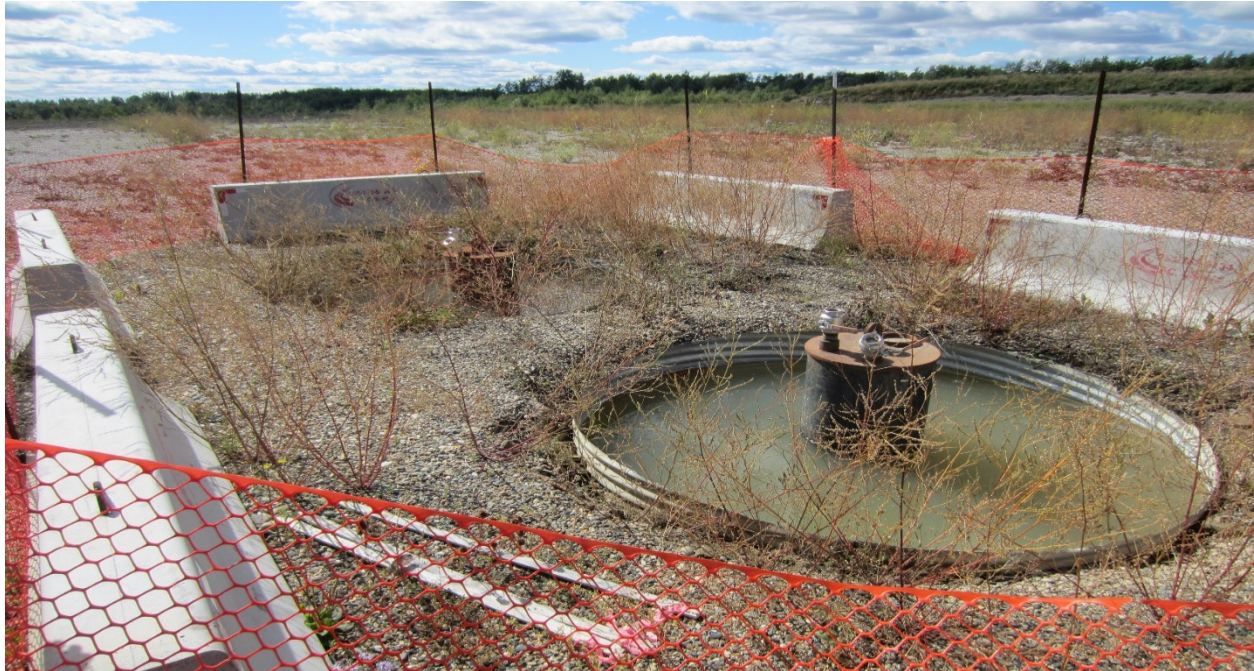
Photo 11. This is well site 16-12-86-22 w6m in the Lower Cache. We stumbled on this site by accident so we do not have information on its status but it is clearly abandoned. However, two well casings are evident.

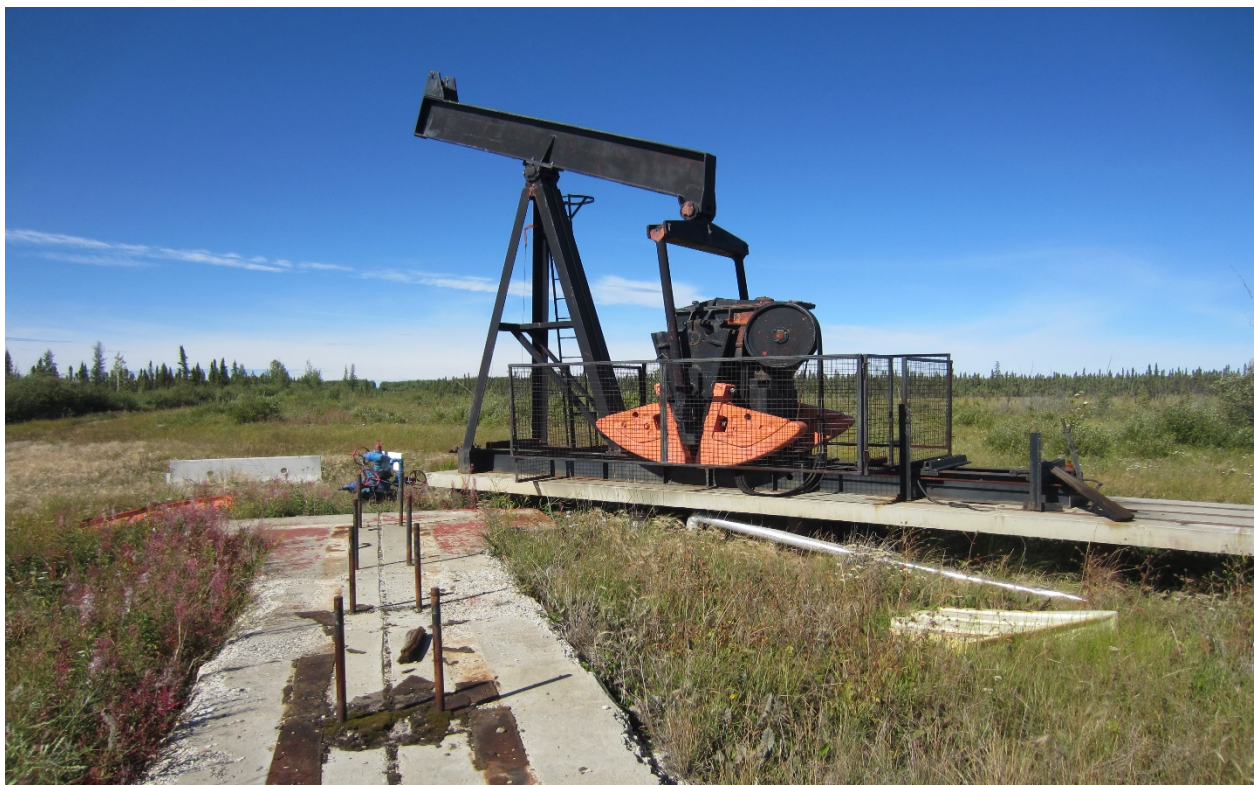
Photo 12. This is well site Peejay d-86-H/94-A-15. It was completed in 1964 and designated as "suspended" in 2007. The old pumpjack remains on site.

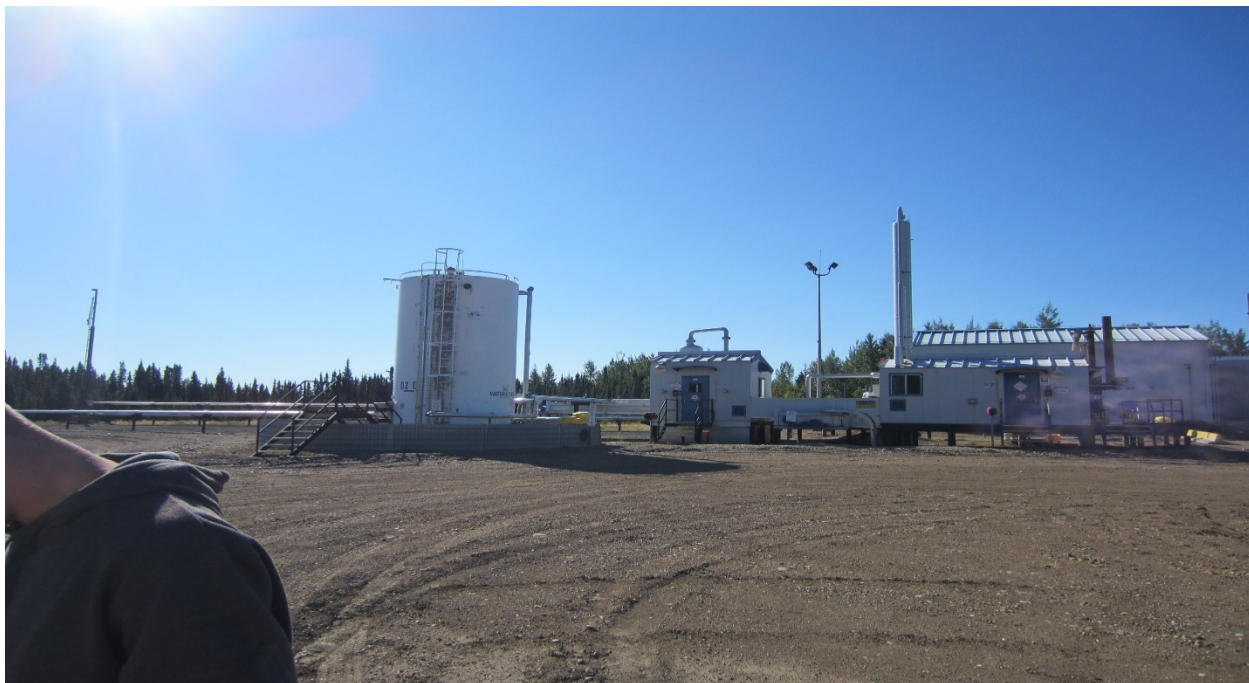
Photo 13. The Mink compressor station near Peejay (d-88-A/94-A-15) has been closed and classified as “suspended” since the year 2000. A coffee maker in the first aider’s shack remains plugged in and set on “Auto Brew”. The pot was empty but hot when we visited the site. Hydrogen sulphide gas was wafting through the air at this site.

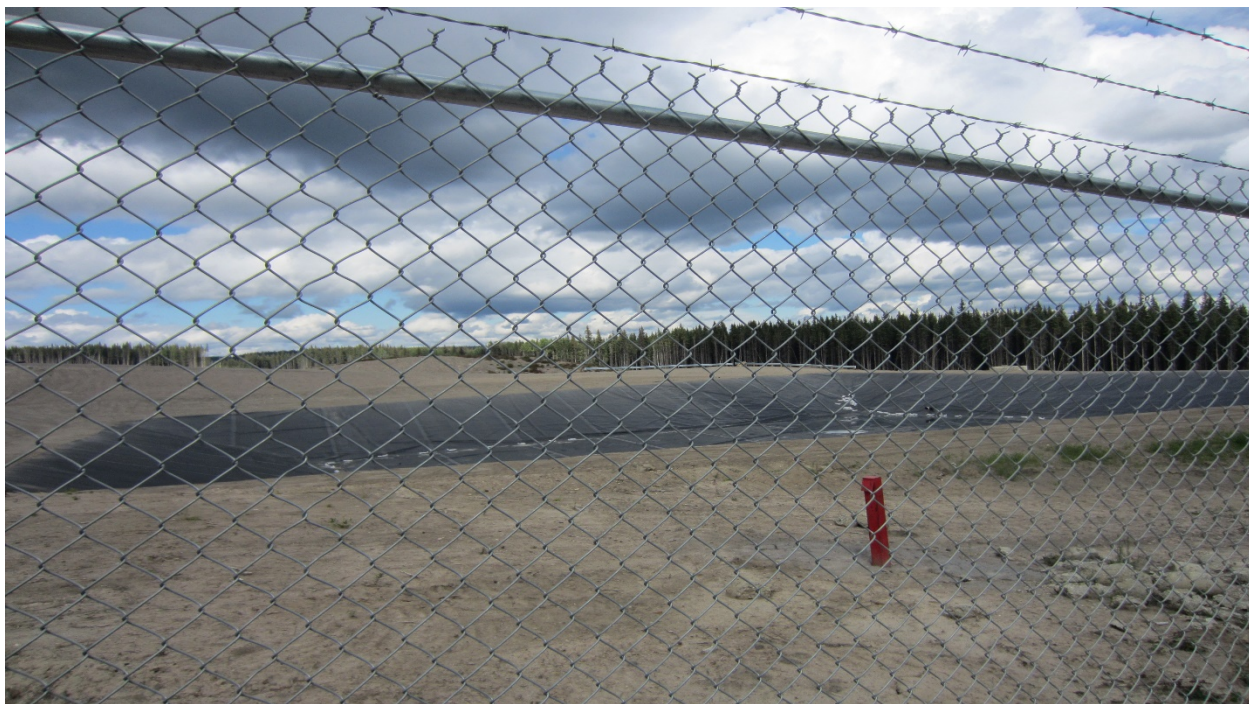
Photo 14. Large (approximately one hectare) process water holding pond at a Progress Energy compressor station site (a-58-h) at KM 16 on the West Gundy road approximately 90 km NW of Fort St. John.

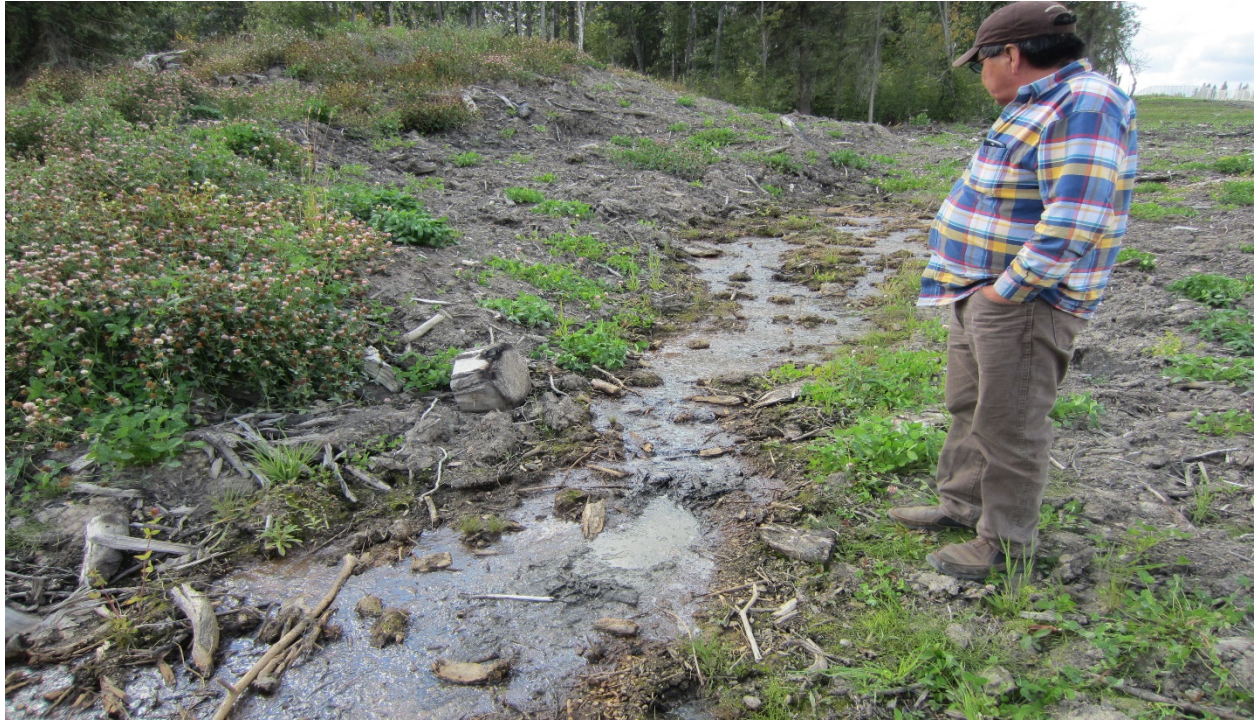
On the date of our visit (August 25), the BRFN commented that the “leak” they had witnessed appeared to have been brought under control (in other words, it was not flowing as copiously as they had seen months earlier) but that there was still some form of discharge taking place at the same location, and they directed us to it (photo 15).

Photo 15. Seep water leaking out of the upslope shoulder of the road at KM 16 on West Gundy Road, downslope of a large process water holding pond.

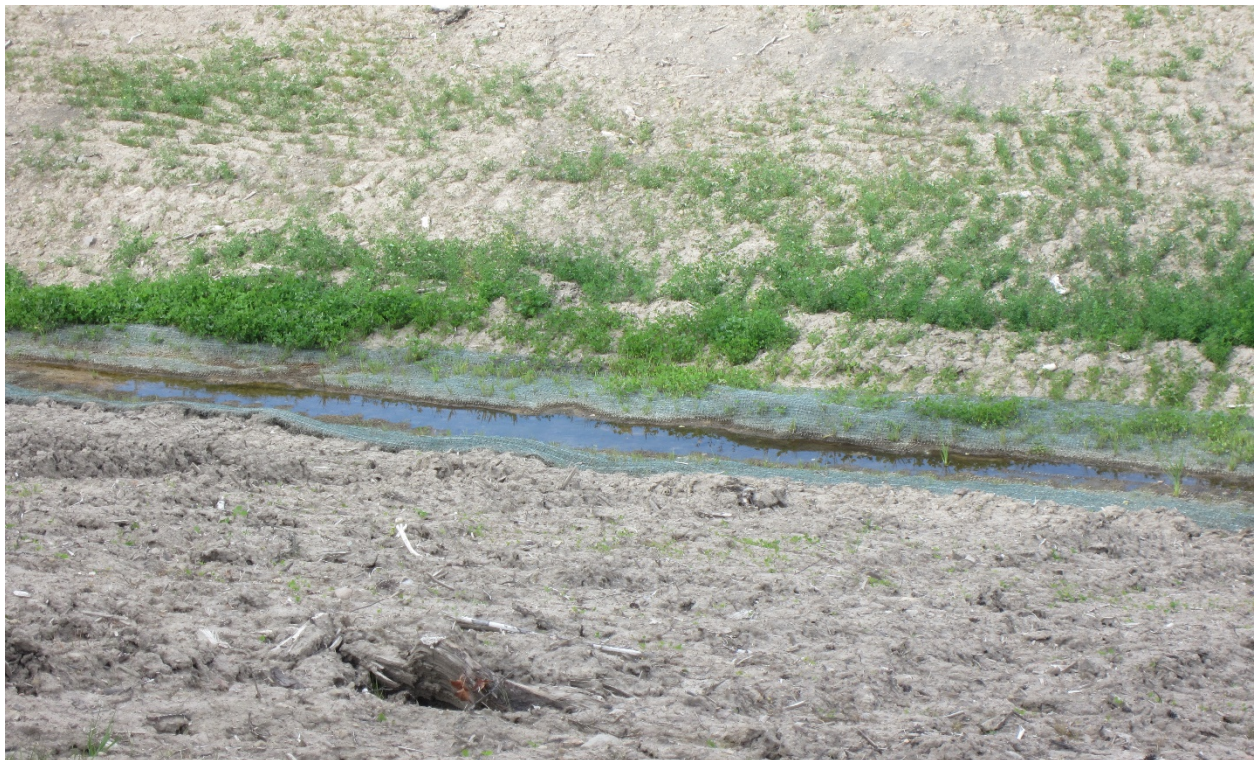
- The water in the pond at the time appeared to be the same colour and had the same odour as the seepage water we had observed downstream;
- On the west side of the pond, seepage was occurring at the base of the retaining dam built to contain the water in the process water holding pond (photo 16);

One logical conclusion from these observations is that the main pond was leaking, allowing contaminated water from inside the pond to escape, possibly through holes or through poorly sealed seams in the geomembrane used to line the ponds.

Photo 16. Seepage occurring at the base of the retaining dam built to contain the water in the process water holding pond at km 16 on the West Gundy Road.

Further investigation is needed to determine if they are leaking and, if so, how extensive those leaks may be. (Based on our observations, they could be substantial.)

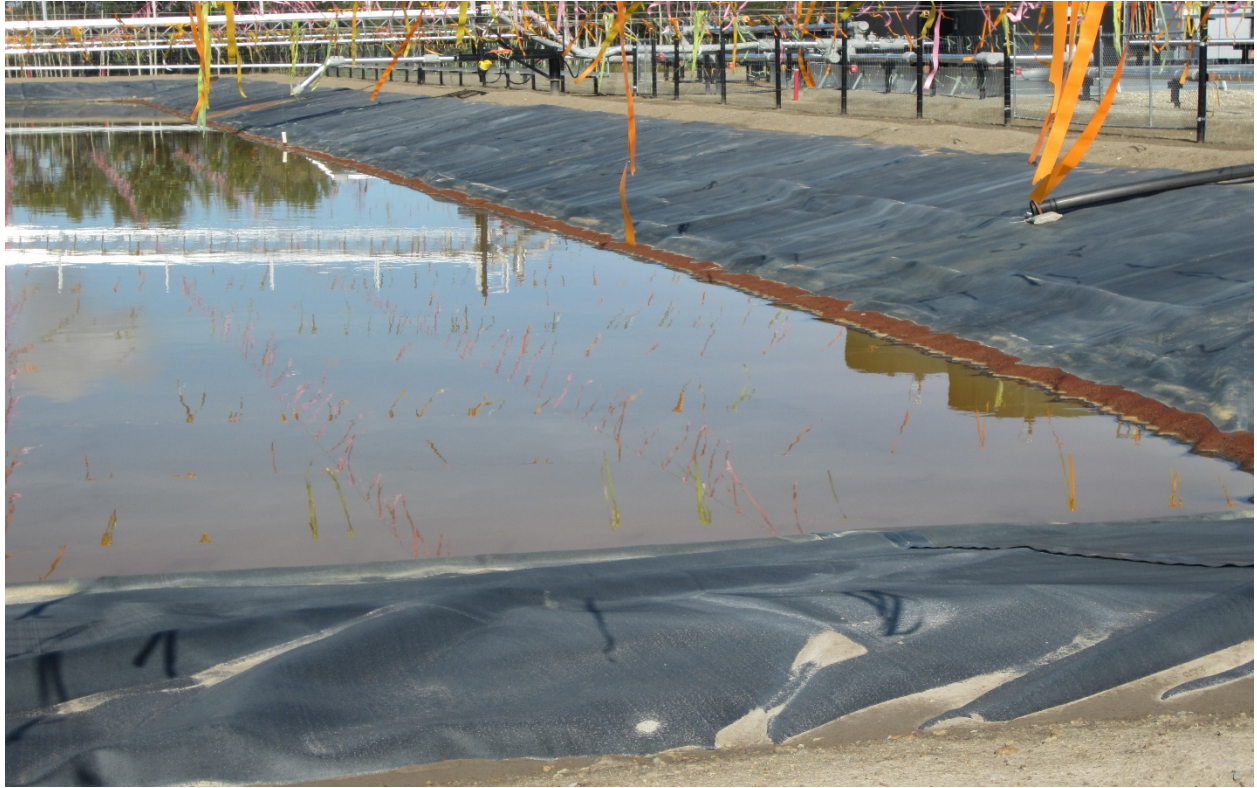
The following day (August 26, 2015), we visited a second Progress Energy compressor station site on East Gundy Road (East Gundy compressor station d-4-H/94-B-16 W6M). Here too, members of the BRFN had, in the past, observed “coloured, smelly water” emanating from the compressor station site, pooling on the road surface, running off the road surface onto the shoulder and on the downslope side of the road and entering ditches and being discharged further downslope through culverts. As with the site on the West Gundy, there was a large pond on site that appeared to be used to store process water (photo 17).

Photo 17. Process water holding pond at East Gundy compressor station site d-4-H/94-B-16 W. Note the reddish colour of the water and the dried sediments on the geotextile liner at the water's edge.

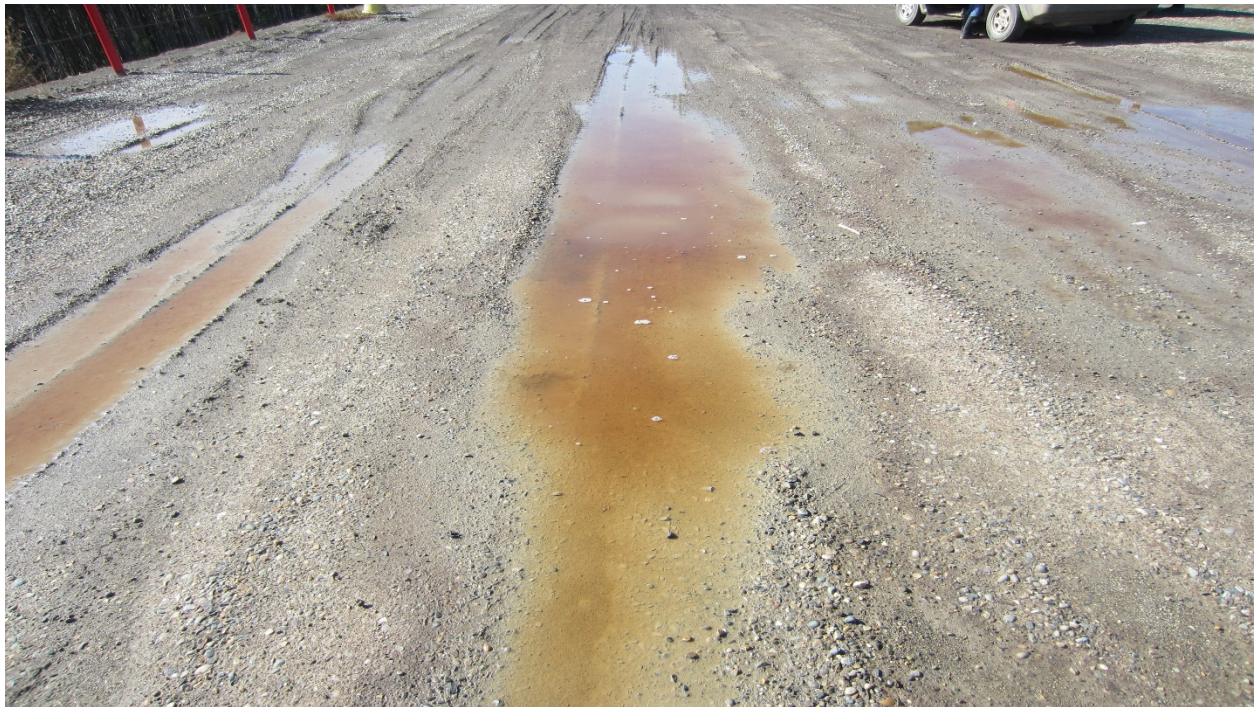
Photo 18. Tea coloured water on road surface immediately adjacent to process water holding pond at East Gundy compressor station site d-4-H/94-B-16 W.

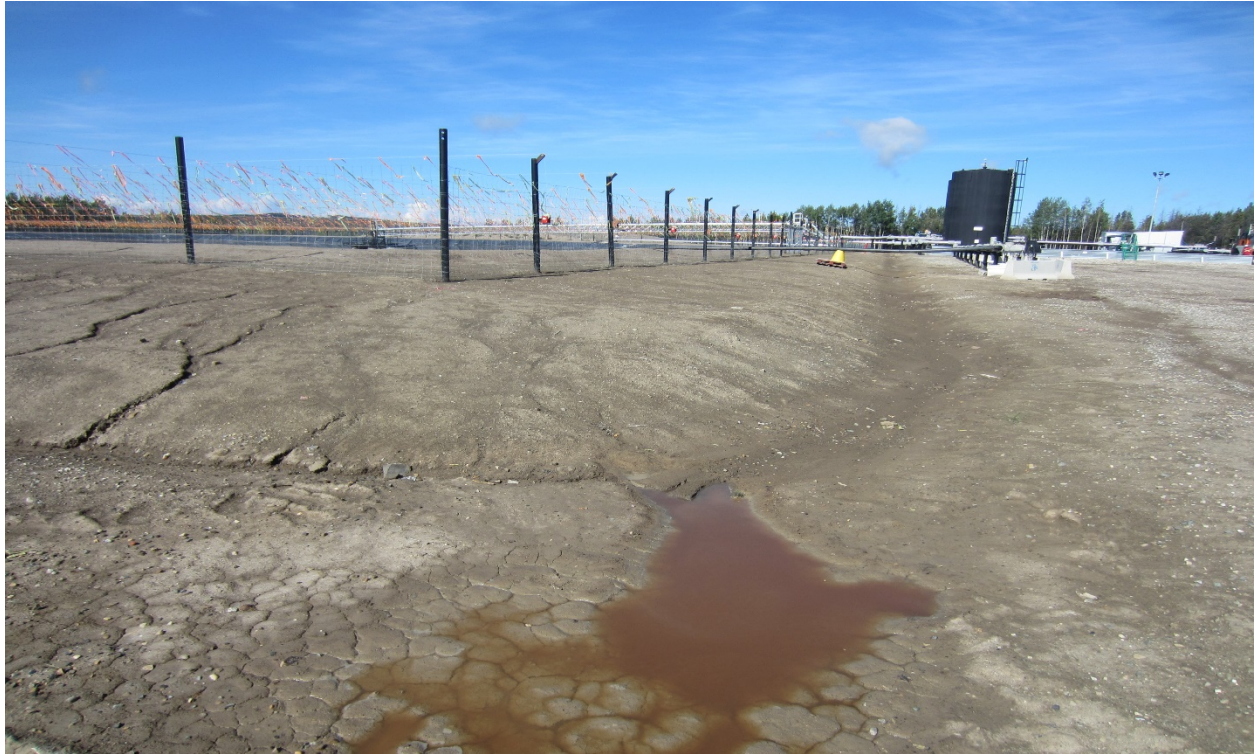
Photo 19. Orange-coloured water seeping out of base of berm on southeast corner of process water holding pond at East Gundy compressor station site d-4-H/94-B-16 W.

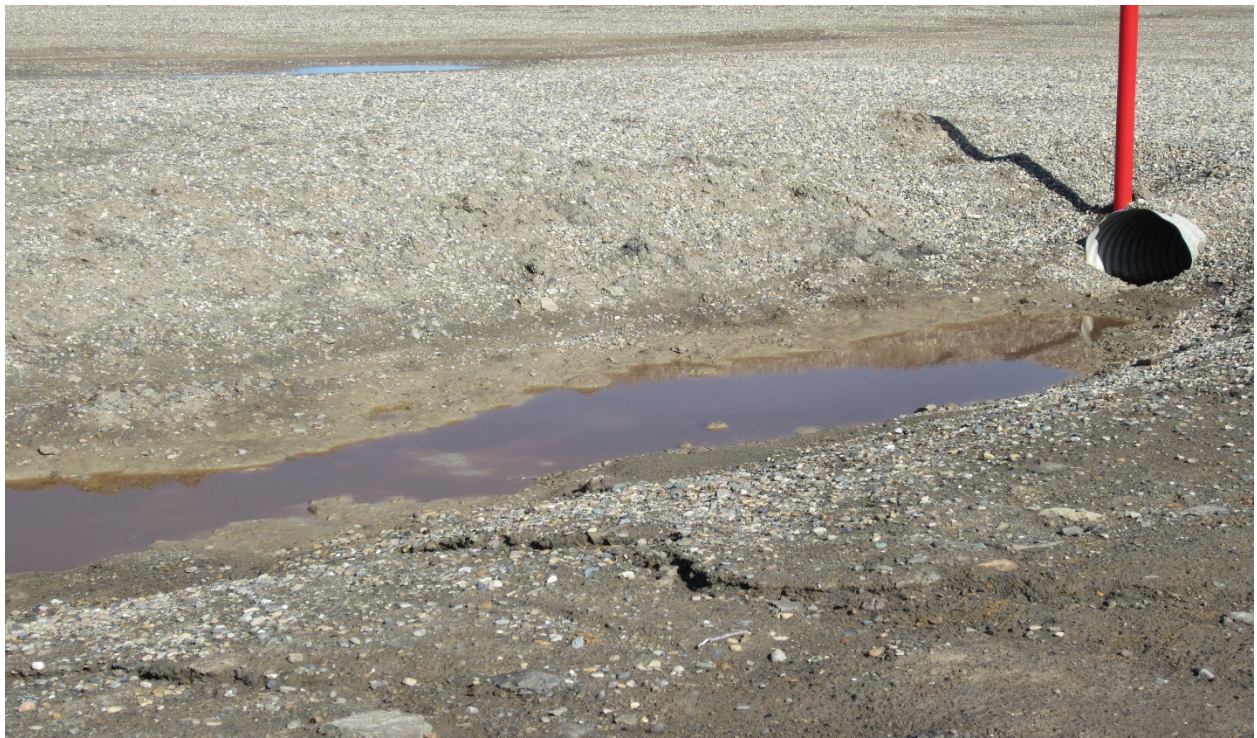
Photo 20. Water from seep depicted in photo 19 flowing down road ditch line to culvert.

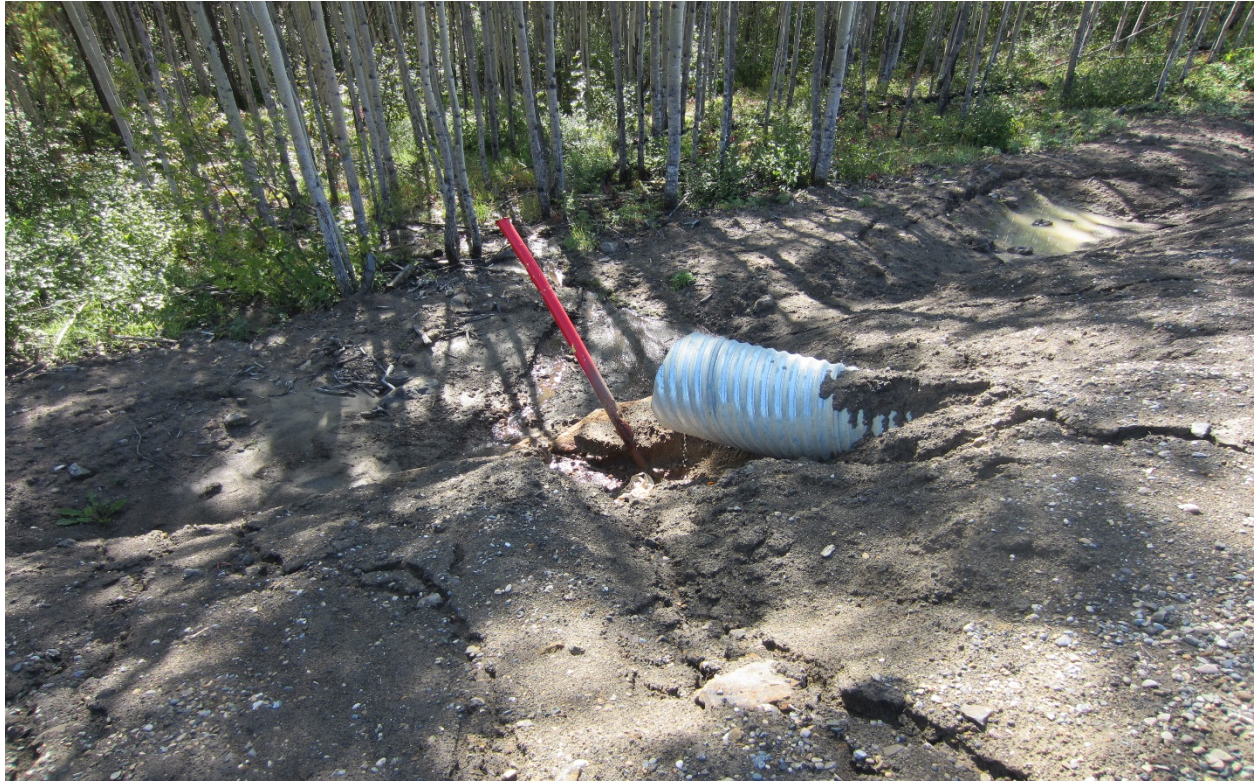
Photo 21. Ditch water in photo 20 exiting culvert on downslope side of road.

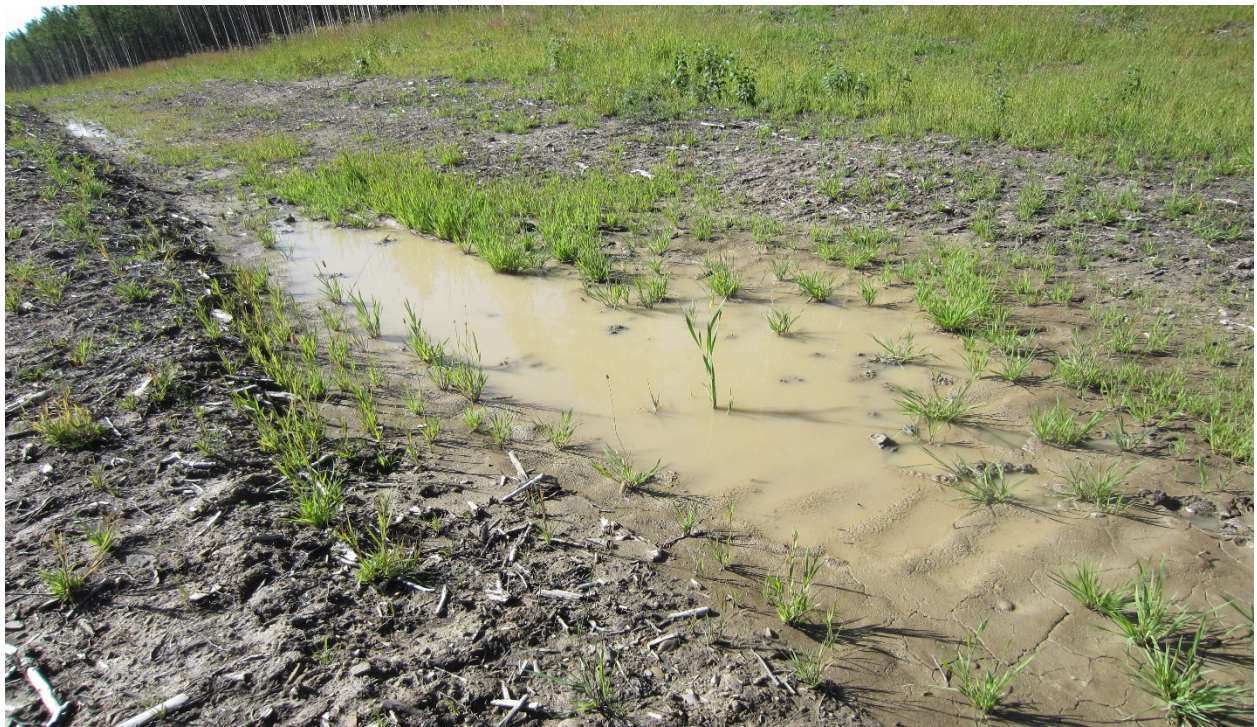
Photo 22. Natural colouration of water in ditch alongside road, uphill, away from East Gundy compressor station site d-4-H/94-B-16 W. This is after a rainfall that occurred the day before.

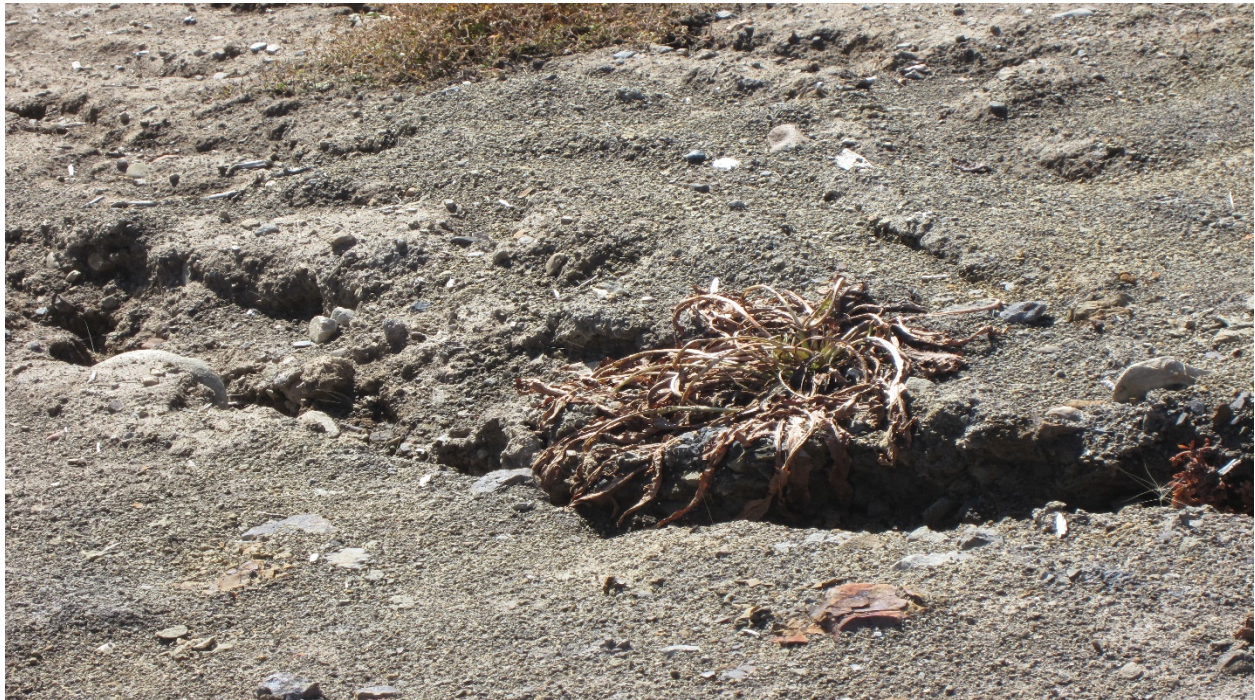
Photo 23. Rilling observed in fill slope on downhill side of the road immediately adjacent to East Gundy compressor station site d-4-H/94-B-16 W. Note the dead vegetation.
