INVESTIGATION BY THE DAVID SUZUKI FOUNDATION INTO ISSUES OF POTENTIAL ENVIRONMENTAL CONCERN RELATED TO OIL AND GAS DEVELOPMENT IN THE MONTNEY SHALE PLAY IN NORTHEASTERN BRITISH COLUMBIA, AUGUST 14 - 28, 2015

Prepared by John Werring
Senior science and policy advisor, David Suzuki Foundation
November 25, 2015

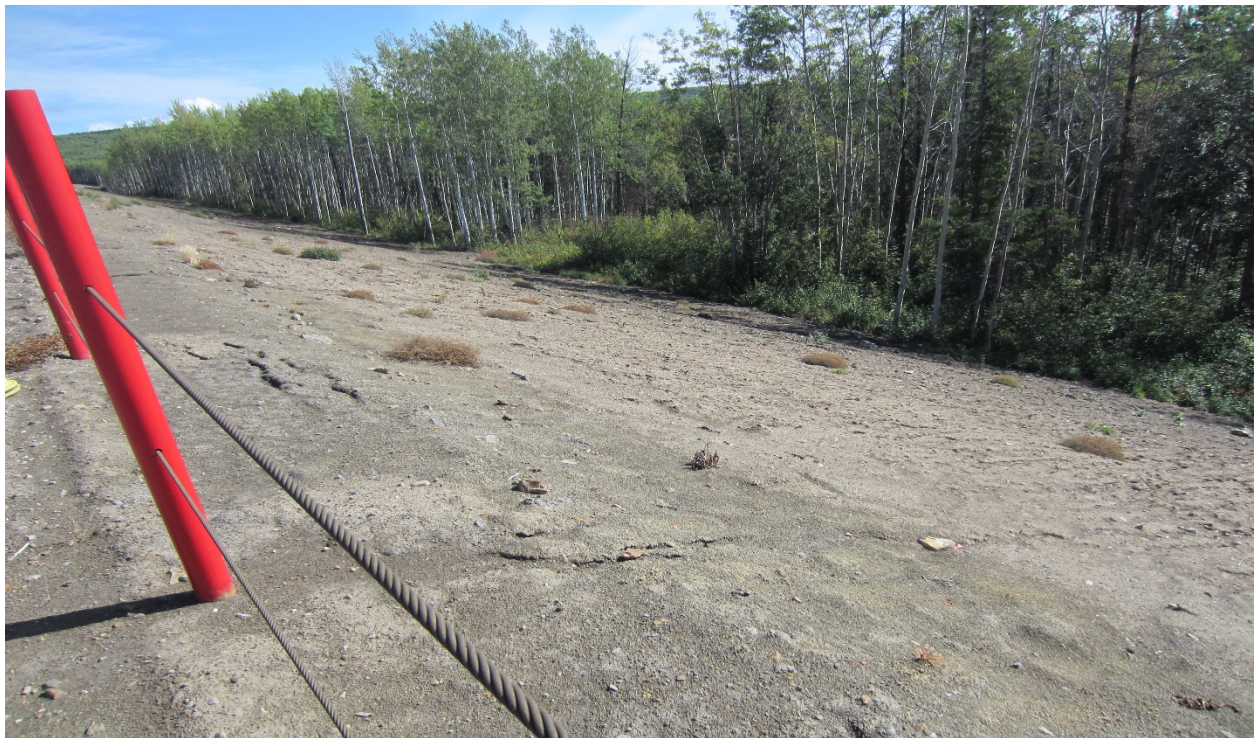
Photo 24. Picture of fill slope of road immediately adjacent to East Gundy compressor station site d-4-H/94-B-16 W. Note signs of rilling and how sparse and brown vegetation is at this location.

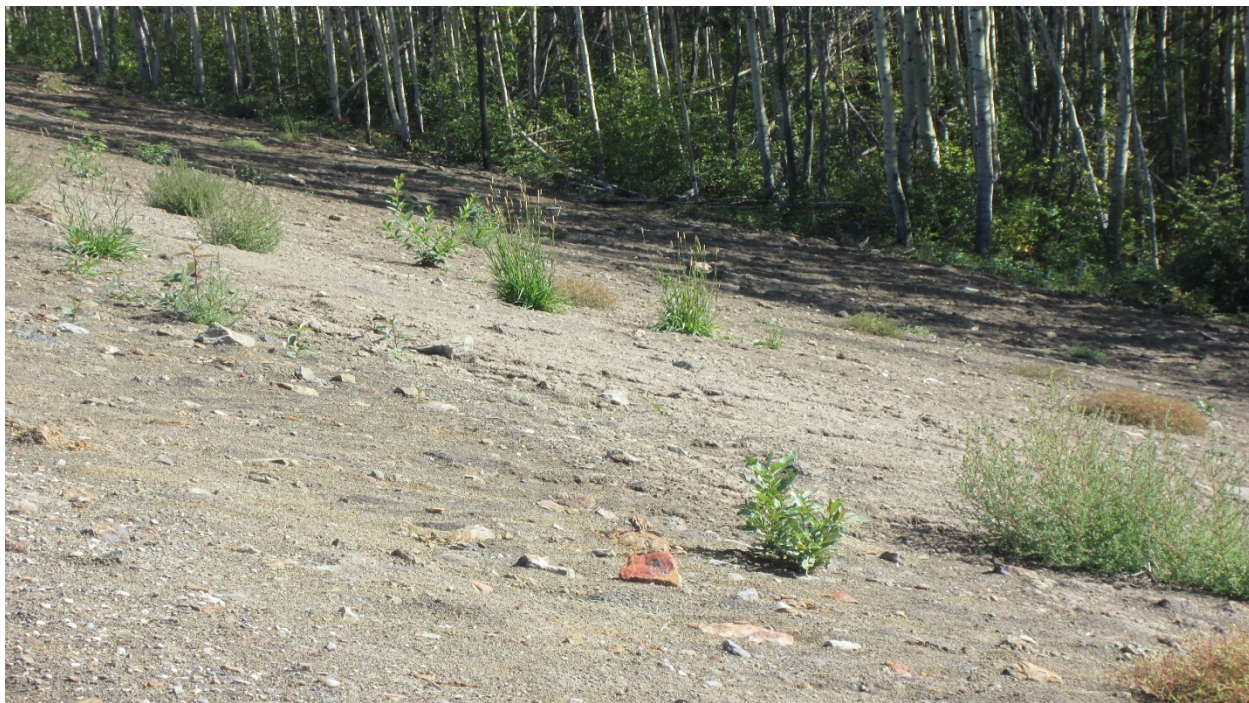
Photo 25. Picture of fill slope on downhill side of road approximately 100 metres east of East Gundy compressor station site d-4-H/94-B-16 W. Note absence of rilling and how more abundant and lush (green and tall) vegetation is at this location.
