High and Dry

AN INVESTIGATION OF SALMON-HABITAT
DESTRUCTION IN BRITISH COLUMBIA

High and Dry: An Investigation of Salmon-Habitat Destruction in British Columbia

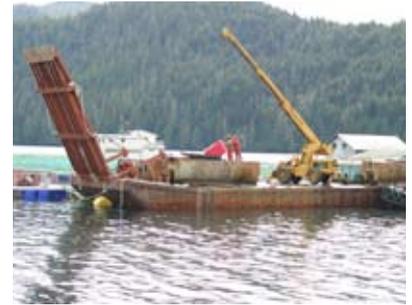
We visited the site on January 23, 2003, and found that the company had 24 fully stocked net pens on site, not 12. The operations also included two feed barges, two accommodation barges (in essence two completely separate farm structures situated side-by-side), several (approximately eight) floating smolt pens, and two smaller floats or rafts (one containing circular pens and another holding mort bins). This was directly contrary to the company's newly approved aquaculture management plan, which had only been approved a month earlier.

highly degraded by past fish-farming activities³ and that a farm of the approved size would result in further habitat damage, we concluded that fish habitat was being harmfully altered, disrupted or destroyed in Sir Edmund Bay in contravention of section 35(1) of the federal *Fisheries Act*. Further, we believed that because the company had again illegally expanded (doubled) the size of its operation over and above what was approved in its management plan and by design doubled the amount of waste output causing increased harm to fish habitat, the company had blatantly ignored the law.

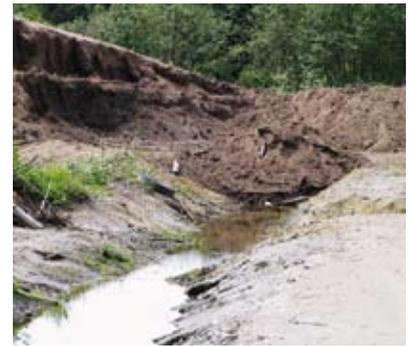
The entire length of the streambed through this particular reach of stream was coated with a layer of fine sand and silt up to 45 centimetres deep in some places, causing the stream to become shallower than it normally would have been and filling in pools that fish would have occupied. Silt barriers (black plastic sheets mounted on wooden stakes) had been placed along approximately 75 metres of stream channel in a futile effort to prevent the stream banks (which comprised loose, disturbed soils) from eroding into the creek. Several of these barriers had collapsed or been buried by sediments that had washed into the stream from surrounding cleared lands. A silt barrier had also been placed on land to prevent surface runoff from entering the creek, but that barrier was also ineffective. The barrier

was flattened, lying sideways and was almost invisible because it was buried by silt and sand. Large concrete blocks had been placed on the shoulder of the road at a stream crossing, but they were being undermined by surface water flow and were perched precariously and seemed ready to fall into the creek at any time. Two culverts under the road crossing were half buried in silt and the upstream side of the culverts was blocked with branches and debris, preventing flow from adequately passing through the pipes.

There was no question at the time that harmful alteration of fish habitat had occurred in this stream, including removal of riparian vegetation and infilling of the creek with sediment from land clearing. It was also evident that silt introductions to the creek would be ongoing until the cleared land around the stream had either been replanted or paved.

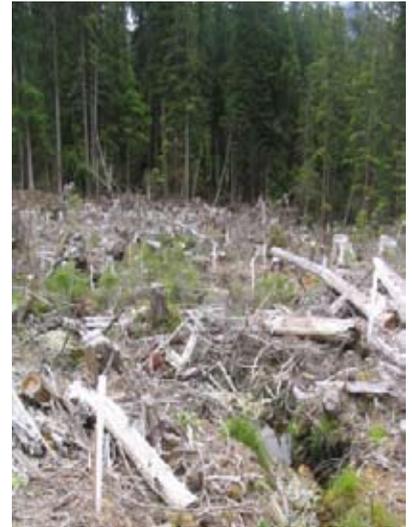
The third affected stream originated as a spring in the northwest corner of the cut block and flowed northeast. This stream appeared to be ephemeral in nature and on that basis was likely properly classified as an S6, non-fish-bearing stream.

However, given that it was of low gradient and directly tributary to an identified fish-bearing stream less than 100 metres downstream, it should have been treated as a fish stream, as this stream could have served as seasonal fish habitat. The entire section of stream within the cut block was clear-cut.

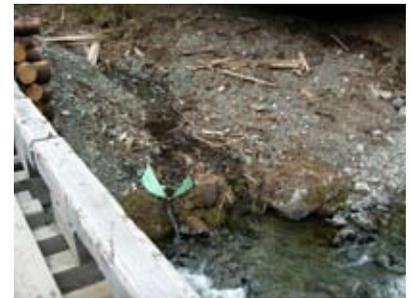
Our investigators travelled the road to Km 14, at which point the road became impassable, so they parked their vehicle and walked the remainder of the way. At Km 15 they observed a massive landslide off the downslope side of the road that deposited approximately 2,500 to 3,000 cubic metres of slide material (rocks, trees, sand) directly into the north branch of Chist Creek. The road at this location was built on a very steep side slope and it was evident that it was built using side-casting⁹. More than half of the road surface had fallen away over a distance of approximately 25 metres, along with the entire side slope below it. The cause of the slide appeared to be uncontrolled ditch water flowing onto the road surface. At the time of our inspection, a small watercourse was flowing onto the road surface due to a culvert being plugged by material that had ravelled off the cut slope above the road. The roadbed was saturated with water and it was evident that the stream flow had undermined a portion of the road causing the road to give way.

Our investigators were unable to determine directly whether the affected branch of Chist Creek contained fish but were later advised by local DFO staff that it was highly likely that the section of stream contained bull trout. (Direct access to the stream to conduct fish sampling at this location was prohibitive due to steep gully

sidewalls and canyon features.) Apparently, salmon were prevented from accessing this stream reach due to a series of cataracts and falls further downstream, near the confluence of this stream and the main stem of Chist Creek.

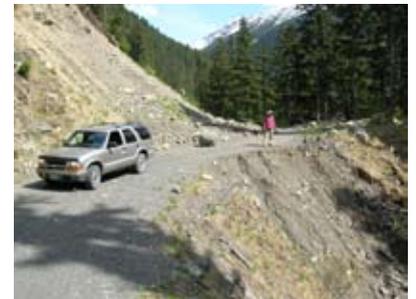
At Km 3 in the Anweiler Creek Drainage, our investigators encountered a significant road sideslope failure that resulted in the deposit of approximately 100 cubic metres of silt and sand and rocks into a stream that is directly tributary to Anweiler creek. Large rocks that had fallen onto the road from a steep cut slope on the upslope side of the road triggered this failure.

At approximately Km 4.5, there was a steep, unstable cut slope. Silt and debris ravelling down the slope had filled the ditch line and was washing down onto the road surface, flowing down the road onto the deck of a bridge spanning Anweiler Creek. This material was then being washed off the bridge deck and deposited into the creek below.

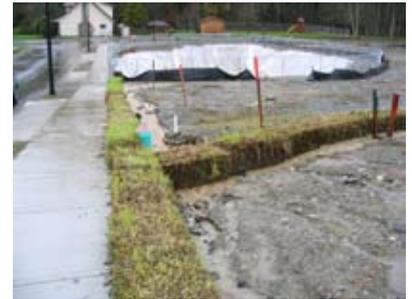
The site had three “storm water retention ponds” two of which, on January 13, were half to two-thirds filled with silt-laden water. The water in these ponds was mostly captured surface water, which had flowed over the bare soil on the cleared lots and had picked up a lot of fine silt. The configuration and function of the ponds only allowed for very short periods of retention before the untreated water was discharged through subsurface drainpipes directly to Millionaire Creek and North Millionaire Creek.

While Foundation staff were on-site it was raining steadily. Water was observed to be running off the cleared lots in rills and channels, causing significant erosion of the topsoil. In one location uncontrolled surface-water flow had severely undermined the footings of one of the buildings under construction. Several cubic metres of soil around the home’s foundation had been washed away.

Attempts had been made by the developer to direct some of the storm flow running over the cleared land into the storm-water retention ponds through the use of strategically placed hay-bale barriers. However, while this may have reduced the erosive force of the water flowing over the exposed soils somewhat, it did little to minimize the amount of silt that was being carried into the storm ponds.

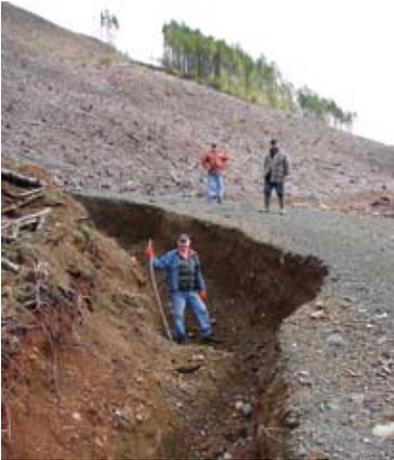
TimberWest's massive steep clear-cuts on the Beaufort Range, coupled with inadequate road-building practices¹¹ and often undersized and improperly installed culverts, resulted in several road washouts following several lengthy, but not particularly abnormal rainstorms (according to local residents) that occurred in late December 2005 to early January 2006 and again in the latter part of 2006 and early 2007. These road washouts caused mudflows across properties downslope of the logging, resulting, in some cases, in significant property damage and massive silt and sediment inputs to fish-bearing streams. Excess stream flows and erosion resulted in the first ever boil-water advisory for the Beaver Creek Water Improvement District. In addition, heavy siltation at a local fish hatchery (McLean's Mill Hatchery) led to massive salmon-fry mortality. The heavy silt inputs also likely caused significant damage to wild-salmon spawning beds. Long-time local residents now fear that due to changing water-flow regimes as a result of upslope logging, the stream reaches below the clear-cuts will dry up completely for the first time since the area was settled.

Our investigators visited the site of one of the most significant road washouts on the Beauforts in January 2006 and again in April 2007. Several road washouts were noted on a cutblock known as Block T141. In January 2006, a significant culvert failure on the lower block road in this cut block resulted in excess flows in one stream that caused significant property damage to a farmer's land downslope of the cut block and resulted in hundreds of cubic metres of silt and sand being deposited into a fish-bearing stream named Woodward Creek. The local DFO habitat-fishery officer also investigated the deposit of silt into the creek.

At the time of our investigation the road washout that caused most of the damage was being repaired but a site inspection led our investigator to believe that insufficient or undersized culverts and a culvert failure were the likely cause of the washout. Our investigator witnessed two stream channels/watercourses that were not culverted, as required under standard coastal road-building practices, and evidence of heavy sediment buildup upslope of the culvert that was being replaced. He concluded that excess water flows (from having three watercourses channelled into one), ditch and road-surface erosion and some channel scour resulted in excess sediment buildup on the upstream of the failed culvert that likely plugged the culvert and forced water onto the road surface. When the culvert blew out, a massive rush of water and sediment downslope likely caused most of the damage to property downstream.

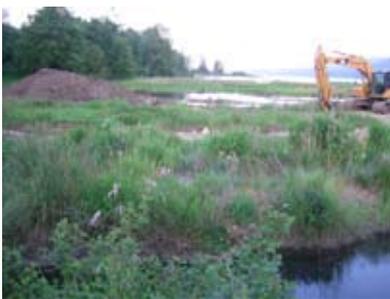
In May 2006 a resident of Nanoose Bay on Vancouver Island contacted us to report that a land developer was in the process of depositing tonnes of rock and sand in an estuary for the purposes of constructing a base on which to build a bed-and-breakfast facility. The fill, upon which the house was to be built, was being deposited within the tidal flood zone of the estuary, thereby directly affecting fish habitat. In addition, two nearby salmon streams were at risk of being impacted.

At the time of the call from the informant (June 2006), the developer had only deposited around 100 cubic metres of fill in the estuary. Over the next few months the amount of fill placed in the estuary increased substantially to several thousand cubic metres while the DFO twiddled its thumbs.
